Contract #: 04-0120F4Cty: SF/ALA Rte: 80 PM: 13.2/13.9File #: 69.28**WELDING INSPECTION REPORT****Resident Engineer:**Siegenthaler, Peter**Address:** 333 Burma Road**City:** Oakland, CA 94607**Report No:** WIR-022086**Date Inspected:** 11-Jan-2011**Project Name:** SAS Superstructure**OSM Arrival Time:** 700**Prime Contractor:** American Bridge/Fluor Enterprises, a JV**OSM Departure Time:** 1900**Contractor:** Zhenhua Port Machinery Company, Ltd (ZPMC), Changxing Island **Location:** Shanghai, China**CWI Name:** An Qing Xiang**CWI Present:** Yes No**Inspected CWI report:** Yes No N/A**Rod Oven in Use:** Yes No N/A**Electrode to specification:** Yes No N/A**Weld Procedures Followed:** Yes No N/A**Qualified Welders:** Yes No N/A**Verified Joint Fit-up:** Yes No N/A**Approved Drawings:** Yes No N/A**Approved WPS:** Yes No N/A**Delayed / Cancelled:** Yes No N/A**Bridge No:** 34-0006**Component:** OBG**Summary of Items Observed:**

OBG Trial Assembly, OBG Segment 12AW-12BW

OBG Seg 14W

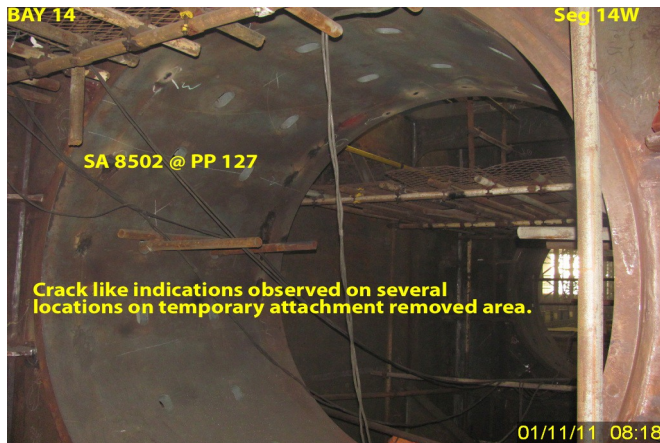
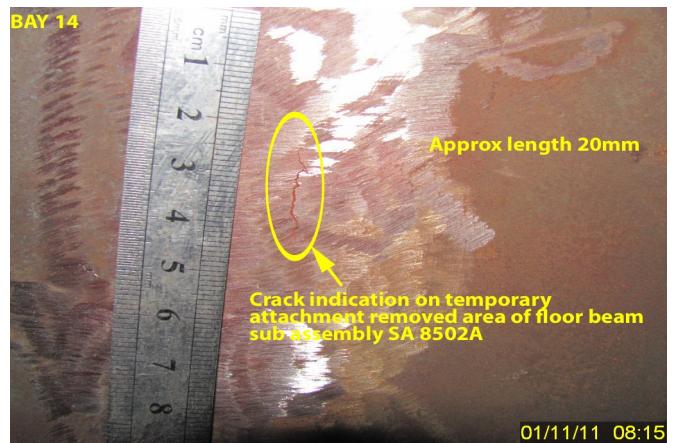
During random in process inspection this QA inspector observed that crack like indications on the temporary attachment removed area of base metal of floor beam subassembly. These indications were observed visually and confirmed by Magnetic Particle Testing (MT). The components are identified as Sub Assembly (SA) Plate SA8502A joining to Floor Beam (FB) 3327 and SA3409A. This issue has been discussed with ZPMC CWI Mr. An Qing Xiang and CT lead QA. Mr. An Qing Xiang informed this QA that this issue would be corrected in manner comply with contract documents. Attached photograph provide additional details.
